RECONNAISSANCE LEVEL SURVEY

I-15; Milepost 11 Interchange
Washington City, Washington County, Utah
PIN 14560, Project No. F-I15-1(116)11

Report Prepared by Nancy Calkins, Horrocks Engineers
For Washington City and Utah Department of
Transportation October 2018

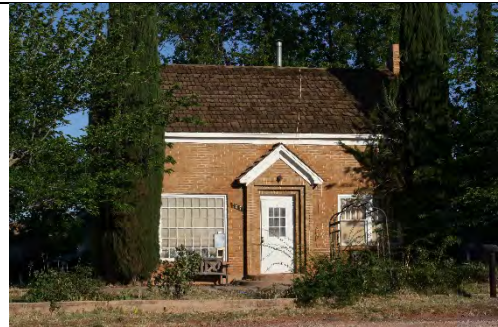
133 N Main Street Map1	1936	Single Dwelling Other Residential Type 1.5 Story Other/Unclear Style Large 1.5 story addition on south half of house, altered materials in synthetic stucco, altered windows.	Inelig./Non-contributing

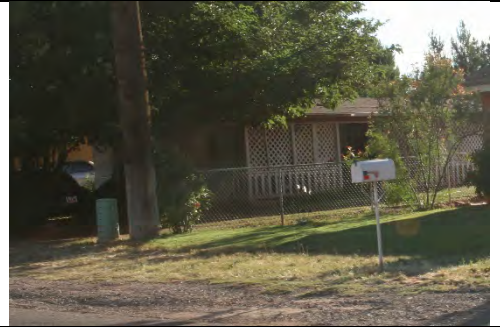
163 N Main Street Map1	1961	Single Dwelling Ranch with Garage 1 Story Ranch/Rambler (Gen.) There is a large addition on the rear of this residence which is visible in the altered roof line on the primary elevation.	Eligible/contributing

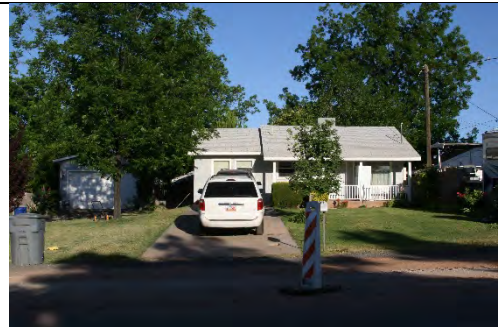
178 N Main Street Map1	1971	Single Dwelling Manufactured Home 1 Story Manufactured Home (Gen.) The windows on this manufactured home have been replaced with vinyl and the although the carport may be an addition it is visible on the 1981 aerial photograph.	Eligible/Contributing

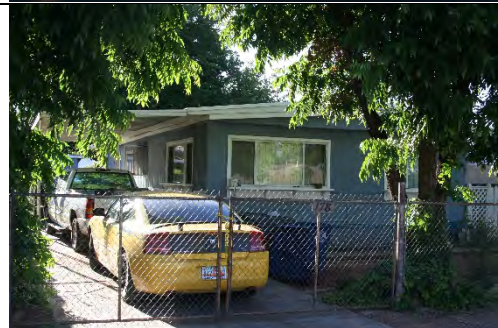
180 N Main Street Map1	1930	Single Dwelling Bungalow 1 Story Bungalow Some of the windows have been replaced but the house retains its original character.	Eligible/Contributing

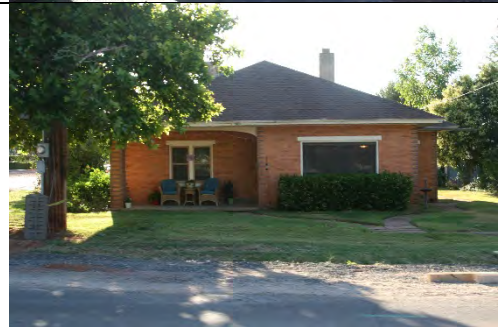
183 N Main Street Map1	1960	Single Dwelling Ranch 1 Story Ranch/Rambler (Gen.) Vinyl siding and vinyl windows	Eligible/Contributing

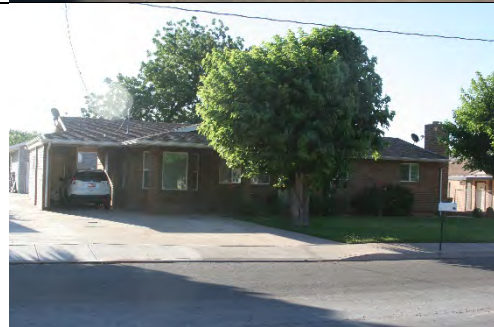
253 N Main Street Map 2	1931	Single Dwelling Box Bungalow 1 Story Bungalow Although this residence retains the original windows, It has been significantly altered application of synthetic stucco on the house and imitation stone on the front porch.	Inelig./Non-contributing Previously recorded as Eligible/Significant

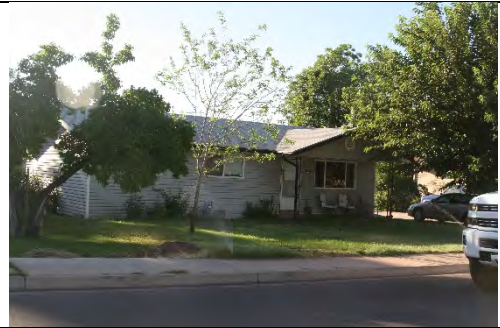
291 N Main Street Map 2	1877	Single Dwelling Central Passage 1.5 Story Gothic Revival Altered materials in vinyl siding, seamed metal roof and vinyl windows.	Inelig./Non-contributing Previously recorded as Eligible/Significant

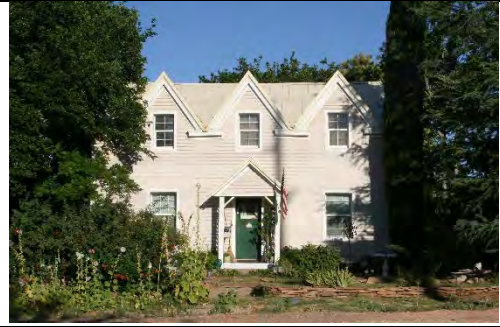
10 W 300 North Map 2	1885 1916 1960	Single Dwelling Ranch 1 Story Ranch/Rambler (Gen.) Windows have been altered and there are additions on the west and north. Washington County has 1916 construction date, city history has 1885 and says it used to be two stories.	Inelig./Non-contributing Previously recorded as Inelig./Non-contributing

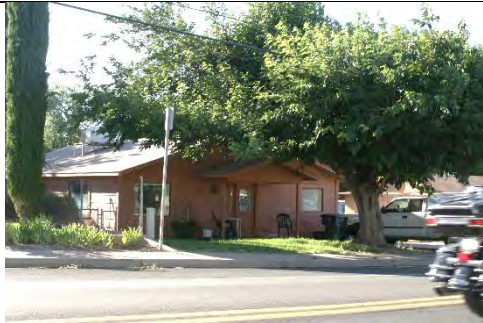
313 E Bulloch Street Map 4	1972	Single Dwelling Ranch 1 Story Ranch/Rambler (Gen.) This house retains original materials, including aluminum slider windows.	Eligible/Contributing

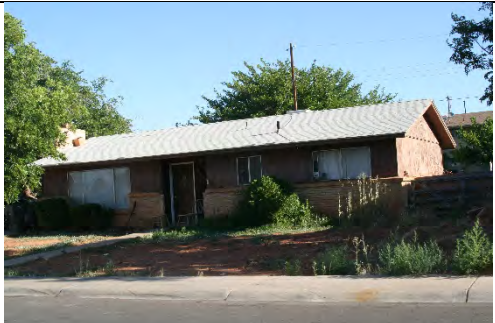
583 N 300 East Map 4	1955	Single Dwelling Early Ranch / Rambler 1 Story Ranch/Rambler (Gen.) Difficult to photograph due to privacy fence and vegetation. There is a rear addition which extends on south elevation	Inelig./Non-contributing

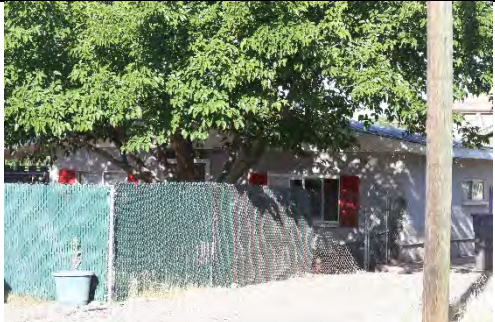
501 N 200 East #1 Map 4	1970	Single Dwelling Manufactured Home 1 Story Manufactured Home (Gen.) Trailer 1. Awning added on the north side of the trailer.	Eligible/contributing

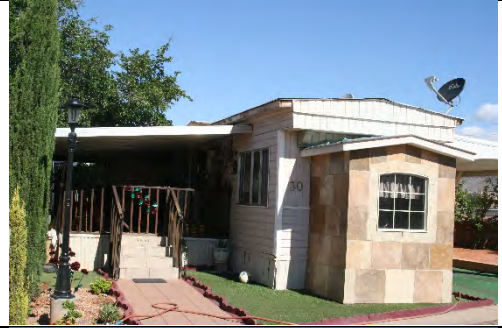
501 N 200 East #51 Map 4	1965	Single Dwelling Manufactured Home 1 Story Manufactured Home (Gen.) Trailer 51. This trailer was moved here and was not at this location during the historic period.	Eligible/contributing
