RECONNAISSANCE LEVEL SURVEY

I-15; Milepost 11 Interchange
Washington City, Washington County, Utah
PIN 14560, Project No. F-I15-1(116)11

Report Prepared by Nancy Calkins, Horrocks Engineers
For Washington City and Utah Department of
Transportation October 2018

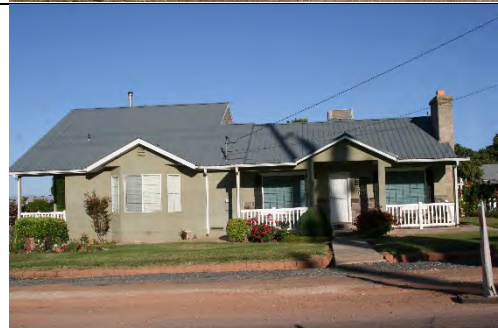
Address	Date	Description	NRHP Eligibility	Photograph
107 N Main Street Map1	1876	Single Dwelling Central Passage 1.5 Story Victorian Eclectic/Period Cottage According to Washington history brick added and windows altered in the 1920s.	Eligible/Significant Previously recorded as Eligible/Significant	 
133 N Main Street Map1	1936	Single Dwelling Other Residential Type 1.5 Story Other/Unclear Style Large 1.5 story addition on south half of house, altered materials in synthetic stucco, altered windows.	Inelig./Non-contributing

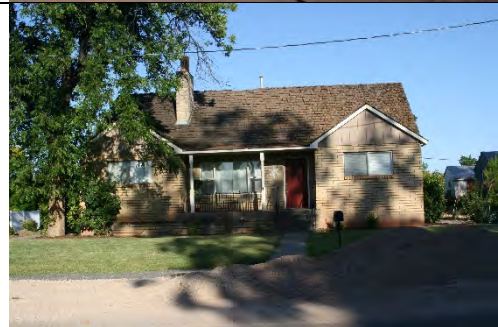
141 N Main Street Map1	1940	Single Dwelling Other Residential Type 1 Story Late 20th C.: Other This style of this residence has been altered by a change in materials of over-sized brick during the 1980s. Also has possible addition of forward-projecting bays and vinyl windows.	Inelig./Non-contributing

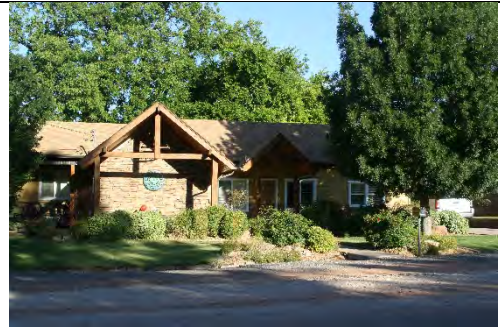
Address	Date	Description	NRHP Eligibility	Photograph
151 N Main Street Map1	1893	Single Dwelling Other Residential Type 1 Story Early 21st C.: Other The type and style of this residence have been significantly altered with additions on the south, front porch, and north carport as well as altered materials throughout.	Inelig./Non-contributing Previously recorded as Inelig./Non-contributing

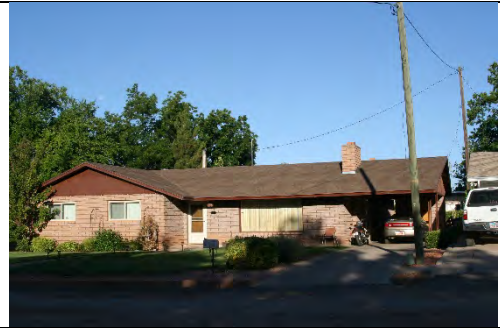
159 N Main Street Map1	1960	Single Dwelling Ranch with Carport 1 Story Ranch/Rambler (Gen.) Except for the replacement of several windows with vinyl, this residence looks much like it did when constructed.	Eligible/Contributing

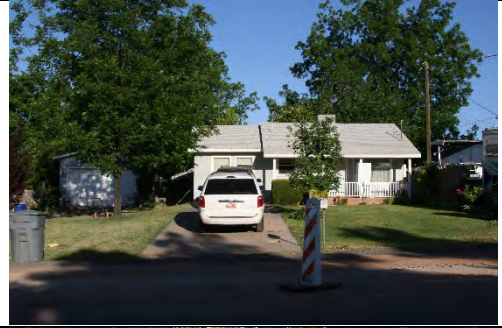
Address	Date	Description	NRHP Eligibility	Photograph
175 N Main Street Map1	1947	Single Dwelling Other Residential Type 1 Story Late 20th C.: Other Constructed as a WWII-era Cottage. The roof has been altered from hipped to gable, porch added, garage added, then enclosed, as well as altered materials in vinyl and synthetic stucco.	Inelig./Non-contributing Previously recorded as Inelig./Non-contributing

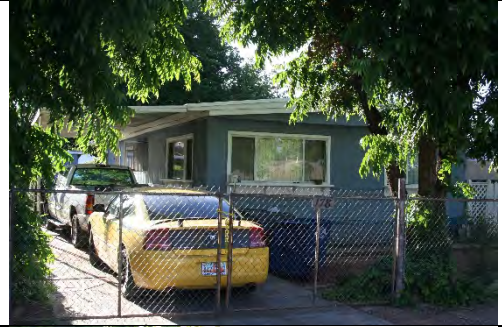
178 N Main Street Map1	1971	Single Dwelling Manufactured Home 1 Story Manufactured Home (Gen.) The windows on this manufactured home have been replaced with vinyl and the although the carport may be an addition it is visible on the 1981 aerial photograph.	Eligible/Contributing

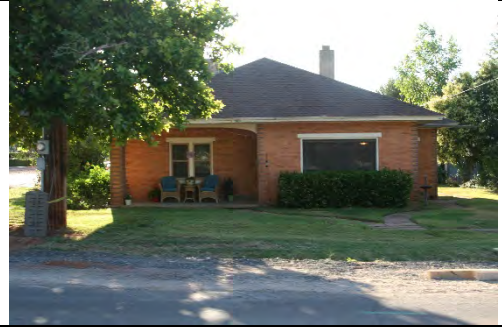
180 N Main Street Map1	1930	Single Dwelling Bungalow 1 Story Bungalow Some of the windows have been replaced but the house retains its original character.	Eligible/Contributing

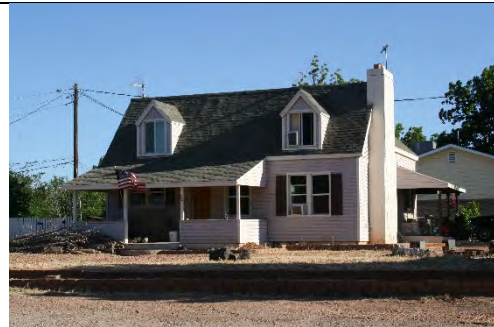
Address	Date	Description	NRHP Eligibility	Photograph
20 W 200 North Map 2	1905	Single Dwelling Crosswing 1.5 Story Late 20th C.: Other Materials altered with vinyl siding and vinyl windows. The style is altered by the enclosure of the porch railing.	Inelig./Non-contributing

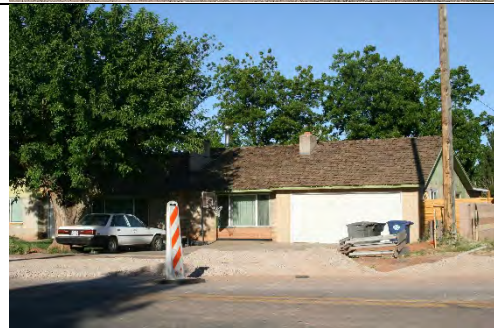
237 N Main Street Map 2	1953	Single Dwelling Ranch with Garage 1 Story Ranch/Rambler (Gen.) The original garage has been enclosed for living space and a new garage has been built on the north elevation. The windows have been replaced with vinyl.	Inelig./Non-contributing

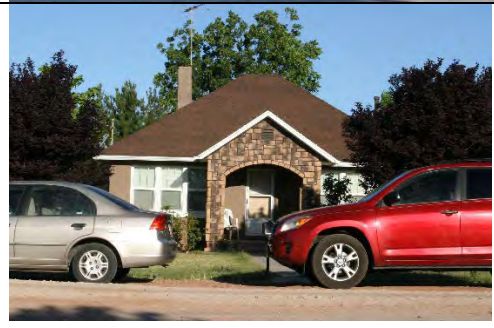
253 N Main Street Map 2	1931	Single Dwelling Box Bungalow 1 Story Bungalow Although this residence retains the original windows, It has been significantly altered application of synthetic stucco on the house and imitation stone on the front porch.	Inelig./Non-contributing Previously recorded as Eligible/Significant

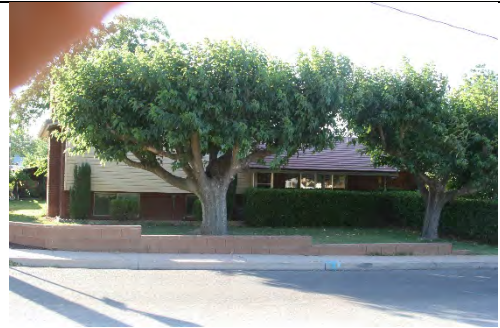
Address	Date	Description	NRHP Eligibility	Photograph
262 N Main Street Map 2	1969	Single Dwelling Split Level with Carport 1.5 Story Split Level (Gen.) Difficult to photograph due to vegetation and the sun. Although the siding has been replaced with vinyl, the dominant material on the house is brick and the style is not altered.	Eligible/Contributing

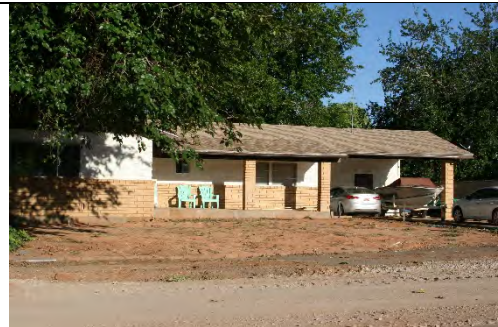
Address	Date	Description	NRHP Eligibility	Photograph
337 N Main Street Map 2	1969	Single Dwelling Manufactured Home 1 Story Late 20th C.: Other Center portion of this residence is a double wide manufactured home. Additions include south wing, porch, carport and roof.	Inelig./Non-contributing

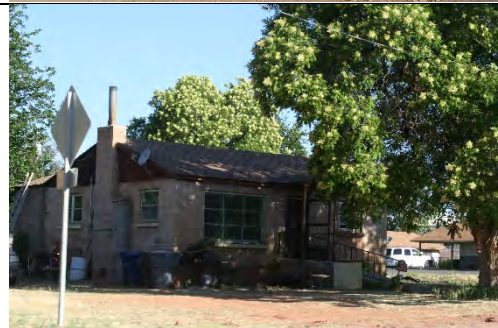
381 N Main Street Map 2	1951	Single Dwelling Box Ranch 1 Story Early Ranch (Gen.) There are storm windows over original, possible rear addition on south elevation and the front steps have been replaced with a ramp.	Eligible/Contributing

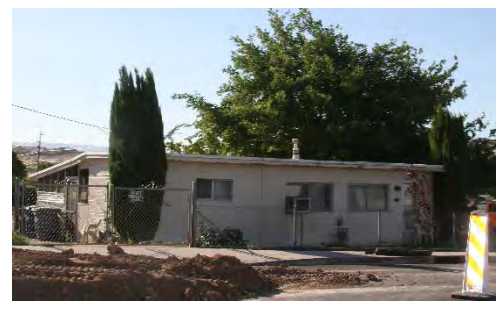
14 N 300 East Map 3	1950 1970	Single Dwelling Ranch 1 Story County records indicate this residence was constructed in 1940, which the style and construction materials do not indicate. Historic aerials indicate the addition on north elevation constructed between 1967 and 1973. Windows replaced at that time with aluminum sliders.	Eligible/Contributing

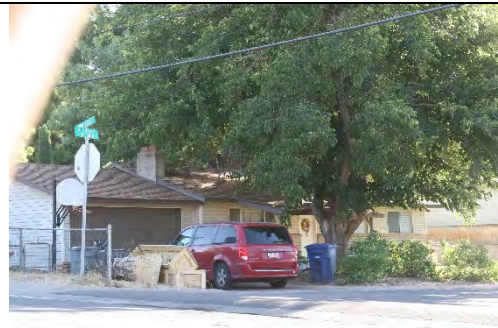
319 E Village Way Map 3	1971	Single Dwelling Ranch with Garage 1 Story Ranch/Rambler (Gen.) Altered materials in vinyl siding and vinyl windows. Garage, porch awning and chimney are possibly additions.	Inelig./Non-contributing

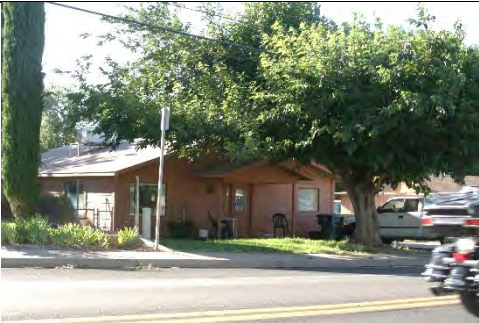
Address	Date	Description	NRHP Eligibility	Photograph
126 N 300 East Map 3	1969	Single Dwelling Perpendicular Ranch 1 Story Ranch/Rambler (Gen.) Windows have been replaced.	Eligible/Contributing

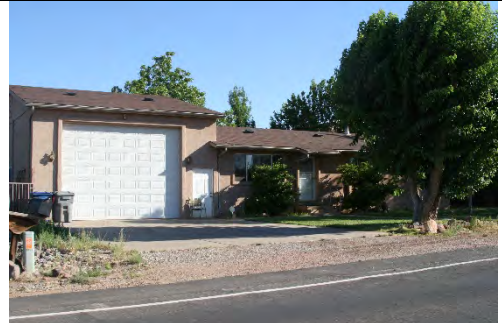
135 E Buena Vista Blvd. Map 4	1970	Single Dwelling Ranch 1 Story Other/Unclear Style Large RV garage added on west, materials and style altered with stucco	Inelig./Non-contributing

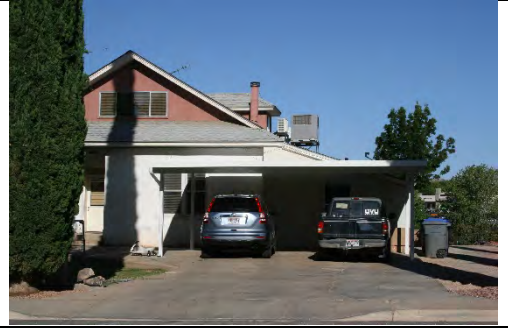
Address	Date	Description	NRHP Eligibility	Photograph
177 N 300 West Map 5	1918 1920 1998	Single Dwelling Bungalow 1 Story There is a shed addition on the north elevation as well as a carport constructed on the primary facade. Materials have been altered with synthetic stucco and gables and dormers clad in wood sheet. The window have been replaced and some with altered openings.	Inelig./Non-contributing Previously recorded as Eligible/Contributing

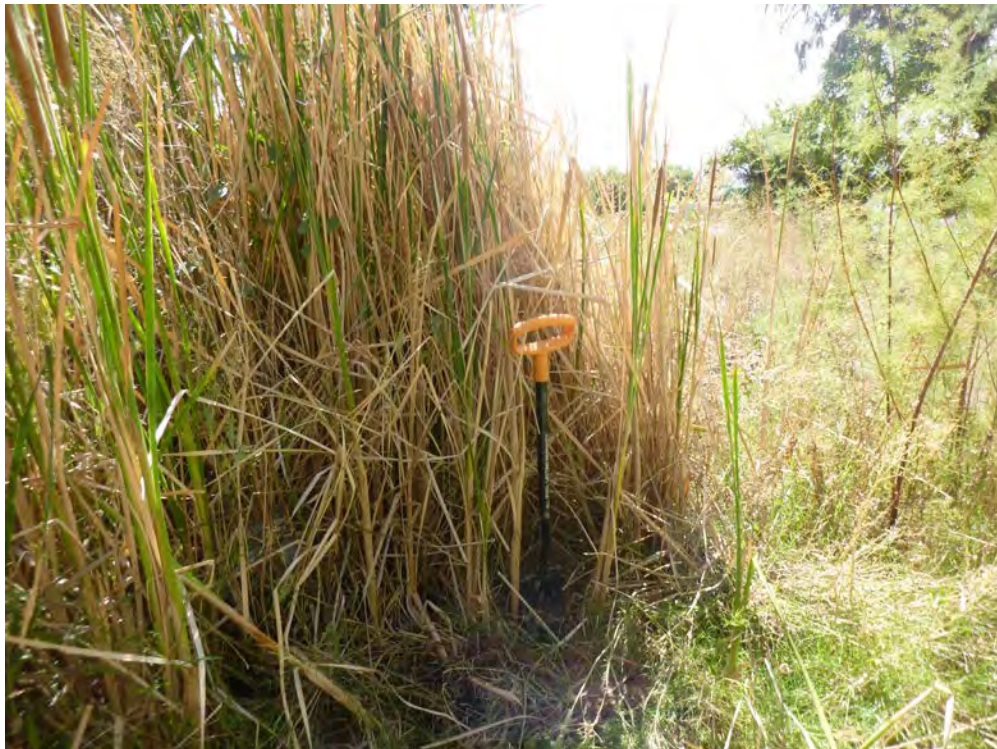
Soil Profile

Remarks: Soil has been disturbed and is mixed with debris (wood, bricks, trash). Even in its disturbed condition, there is enough indication of soil depletion to call it wetland soil.

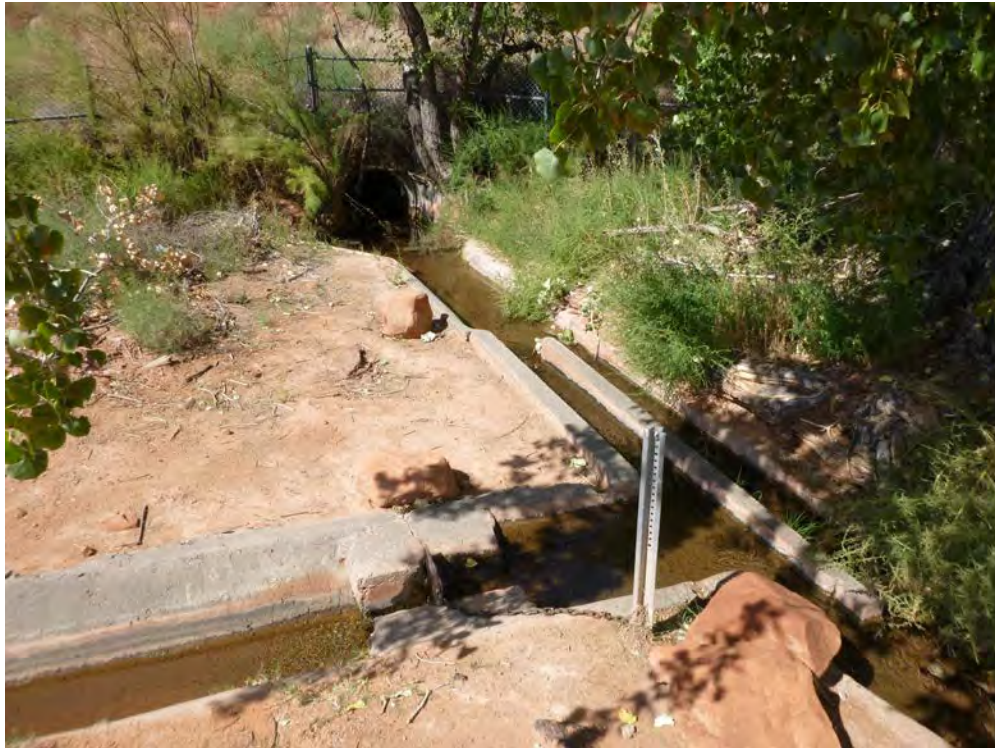
Concrete-lined ditch east of I-15

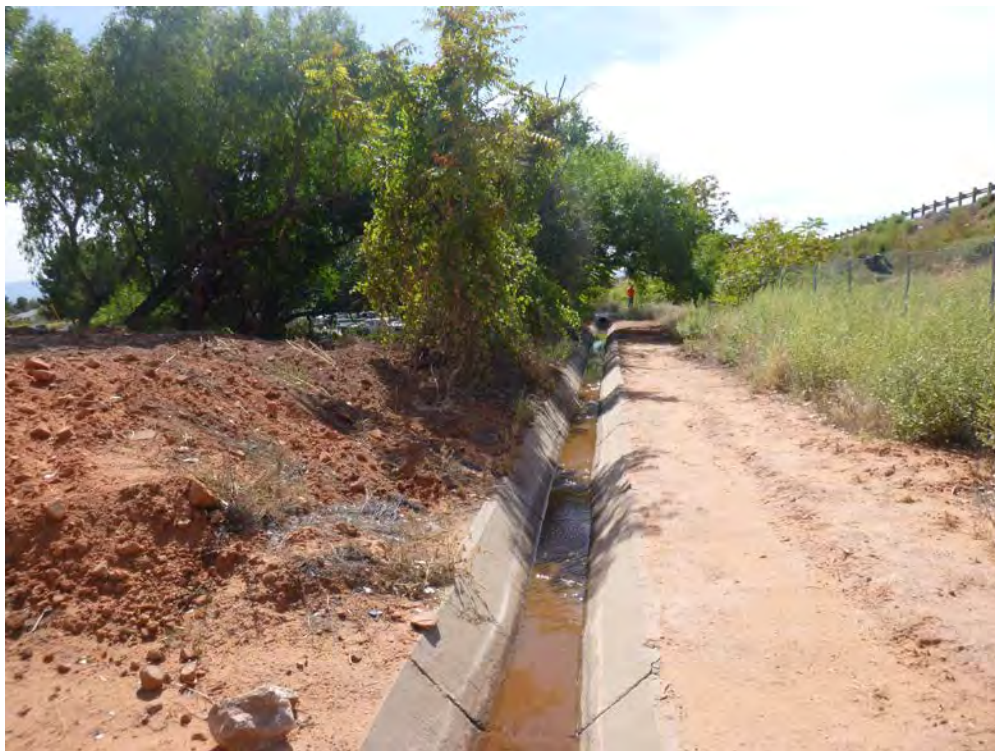
Looking south at concrete-lined ditch

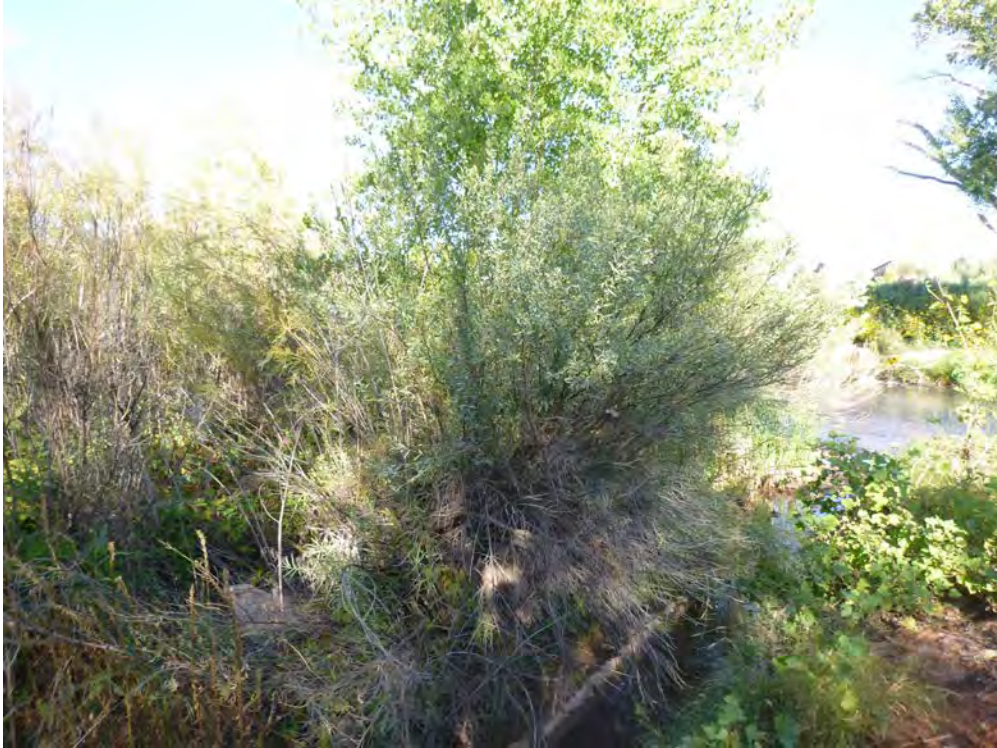
Looking west at PSS wetland near Warm Springs
